BUILDING
MATERIALS
AND
STRUCTURES

REPORT BMS48

Structural Properties of
"Precision-Built" Frame Wall
and Partition Constructions

Sponsored by
the Homasote Co.

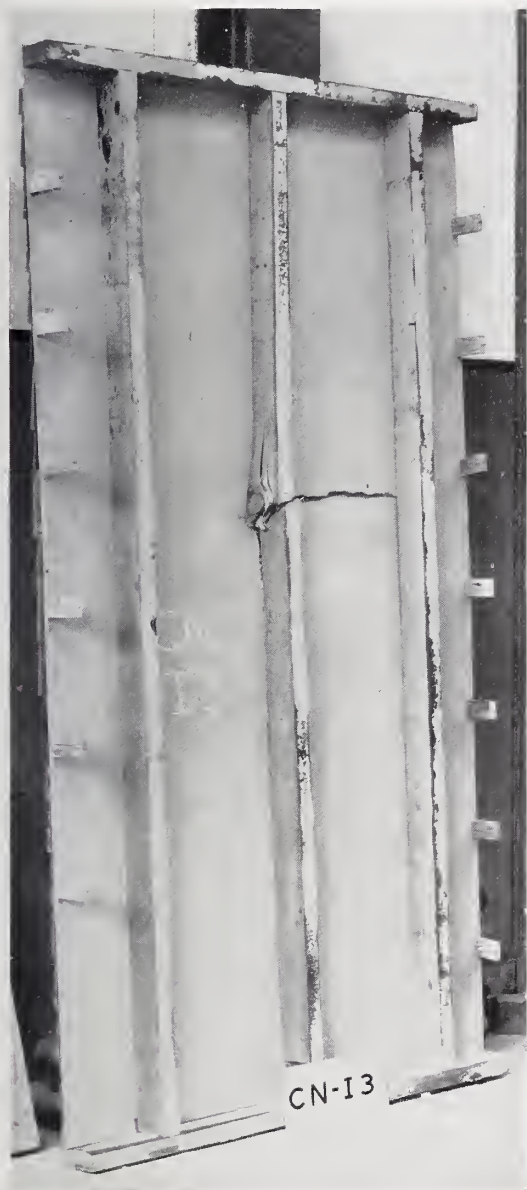
FIGURE 4.—Wall CN.

Two extremes in quality of framing are shown. The center stud is about the lowest and the two outer studs are the highest grade.

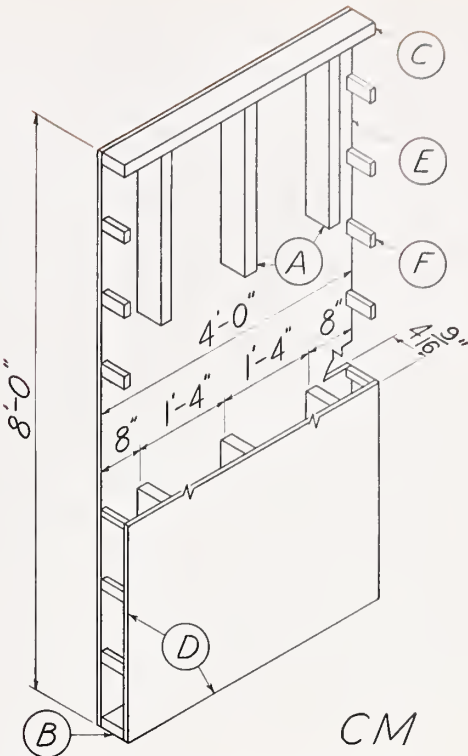
FIGURE 7.—Four-foot wall specimen CM

A, studs; B, floor plate; C, top plate; D, outside face (nailed); E, inside face (glued); F, spacer.

The 4-ft wall specimens, shown in figure 7, were 8 ft 0 in. high, 4 ft 0 in. wide, and 4¹/₁₆ in. thick. Each was a wood frame to which the faces were fastened. The frame consisted of three studs, A, fastened to a floor plate, B, and a top plate, C. Both the outside face, D, and the inside face, E, consisted of a single sheet of fiberboard. The overhanging edges of the faces were supported by spacers, F.

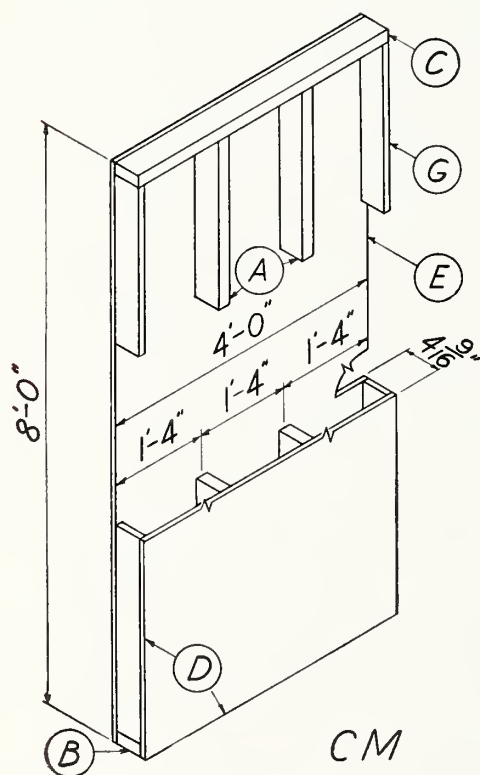
FIGURE 8.—Four-foot wall specimen *CM*, with half-sized studs.

A, full-sized studs; *B*, floor plate; *C*, top plate; *D*, outside face; *E*, inside face; *G*, half-sized stud.

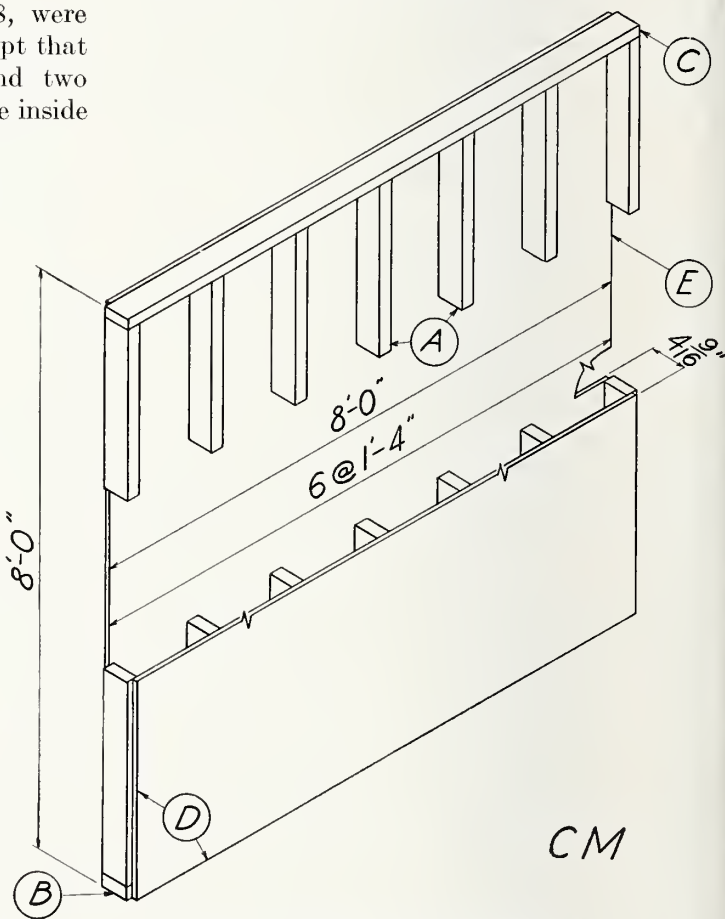
FIGURE 9.—Eight-foot wall specimen *CM*

A, full-sized studs; *B*, floor plate; *C*, top plate; *D*, outside face; *E*, inside face.

The 8-ft wall specimens, shown in figure 9, were 8 ft 0 in. high, 8 ft 0 in. face width, and $4\frac{9}{16}$ in. thick. The specimens were similar to the

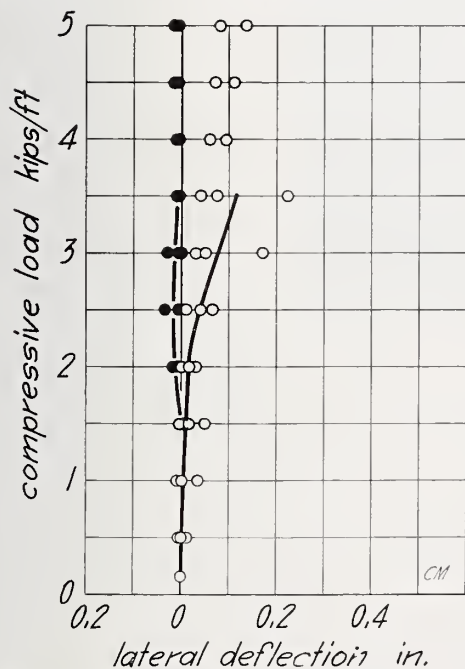
FIGURE 12.—Compressive load on wall CM.

Load-lateral deflection (open circles) and load-lateral set (solid circles) results for specimens CM-C1, C2, and C3. The load was applied 1.21 in. (one-third the thickness of the frame) from the inside surface of the studs. The loads are in kips per foot of actual width of specimen. The deflections and sets are for a gage length of 7 ft 10 in., the gage length of the deflectometers.

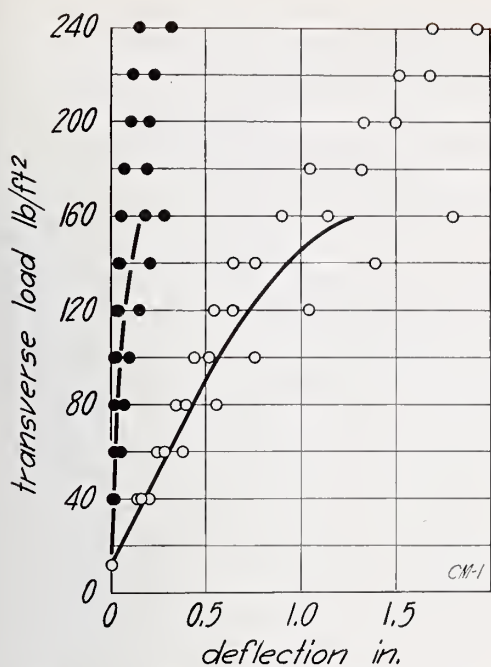
FIGURE 14.—Transverse load on wall CM, load applied to inside face.

Load-deflection (open circles) and load-set (solid circles) results for specimens CM-T1, T2, and T3 on the span 7 ft 6 in.

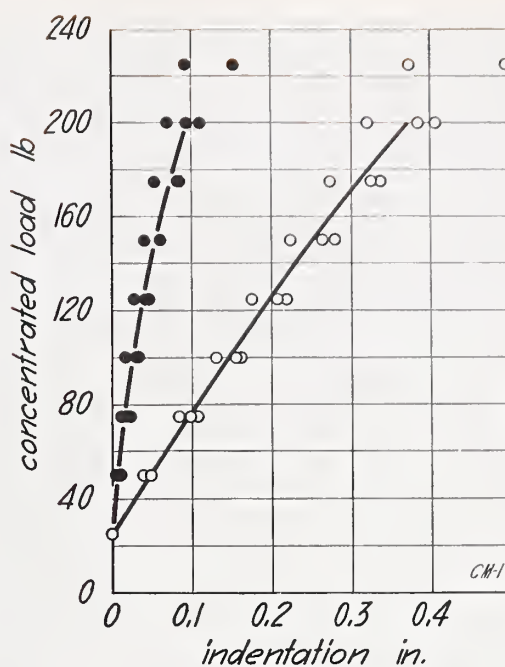
FIGURE 16.—Concentrated load on wall CM, load applied to inside face.

Load-indentation (open circles) and load-set (solid circles) results for specimens CM-P1, P2, and P3.

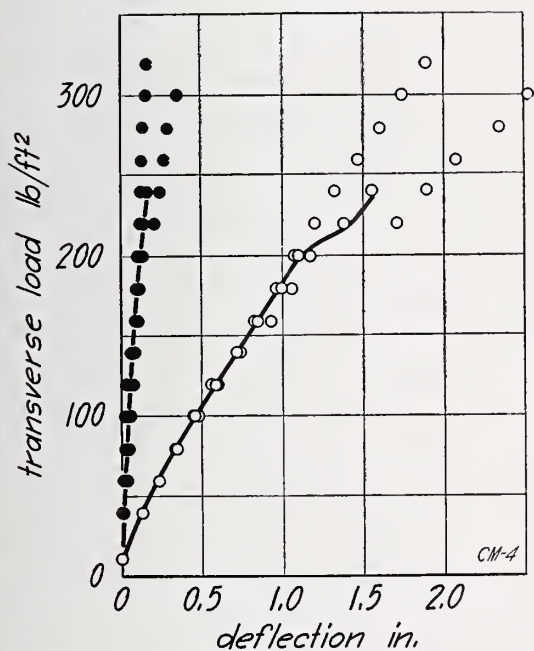
FIGURE 15.—Transverse load on wall CM, load applied to outside face.

Load-deflection (open circles) and load-set (solid circles) results for specimens CM-T4, T5, and T6 on the span 7 ft 6 in.

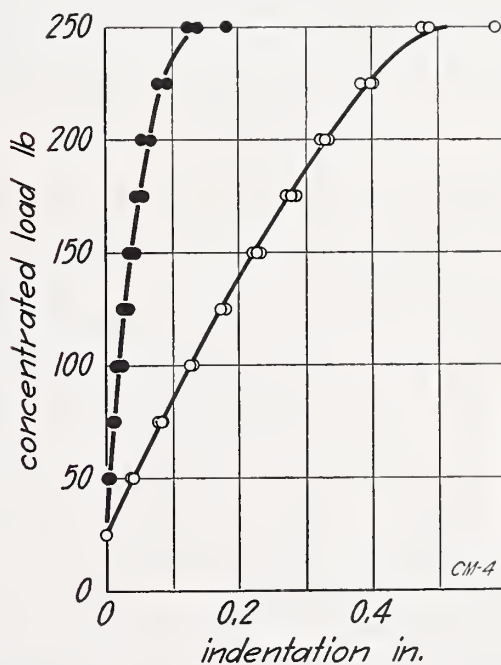
FIGURE 17.—Concentrated load on wall CM, load applied to outside face.

Load-indentation (open circles) and load-set (solid circles) results for specimens CM-P4, P5, and P6.

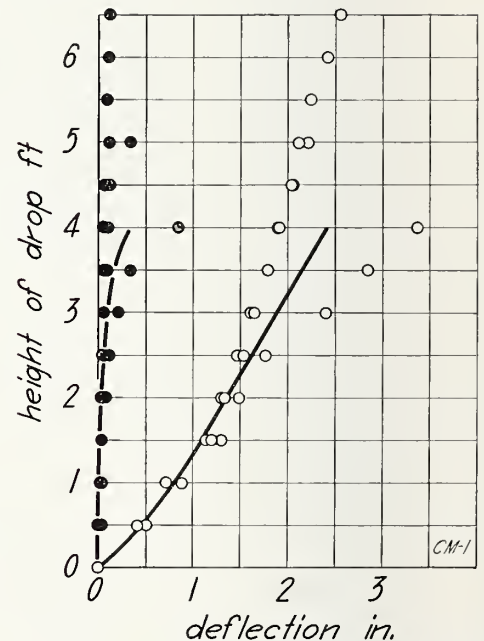
FIGURE 19.—Impact load on wall CM, load applied to inside face.

Height of drop-deflection (open circles) and height of drop-set (solid circles) results for specimens CM-11, 12, and 13. The sandbag struck the center of the specimen directly over a stud.

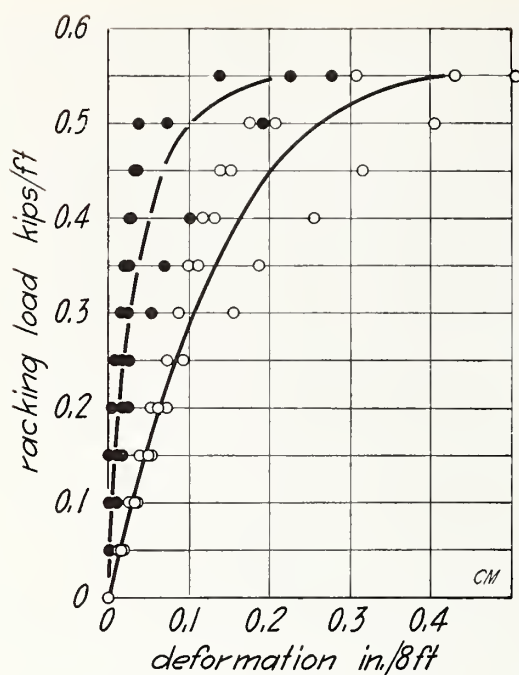
FIGURE 22.—Racking load on wall CM.

Load-deformation (open circles) and load-set (solid circles) results for specimens CM-R1, R2, and R3. The loads are in kips per foot of face width of specimen (8 ft 0 in.).

Under the maximum loads the fiberboard on the inside face of each specimen separated from the glued surface of the frame, and the frame was displaced relative to the inside face. The nails passing through the inside face into the top plate and into the stud at the unloaded edge tore through the edges of the fiberboard. The nails passing through the outside face into the

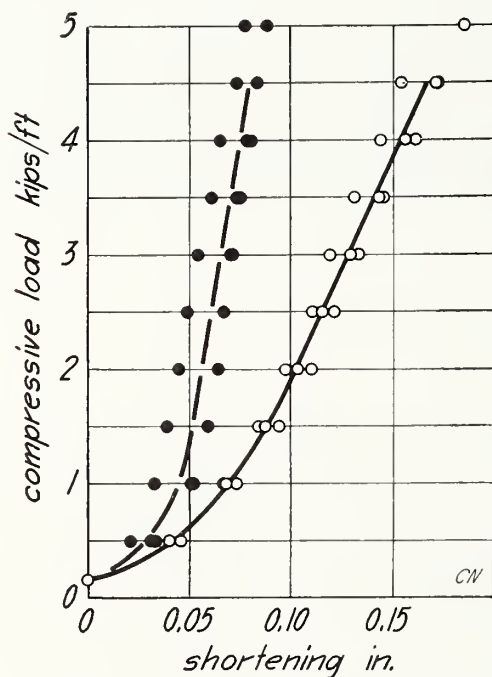
FIGURE 28.—Compressive load on wall *CN*.

Load-shortening (open circles) and load-set (solid circles) results for specimens *CN-C1*, *C2*, and *C3*. The load was applied 1.21 in. (one-third the thickness of the frame) from the inside surface of the studs. The loads are in kips per foot of actual width of specimen.

The fiberboard on the inside face of specimen *C1* began to separate from the top plate under a load of 3.0 kips/ft; on specimen *C2*, under a load of 5.0 kips/ft; and on specimen *C3*, under the maximum load. At the maximum load the top plate of each specimen crushed locally at

the inside edges of the studs. This was accompanied by separation of the fiberboard on the inside face from the upper half of the studs. The outer studs of specimen *C3* split at the top, but none of the studs ruptured.

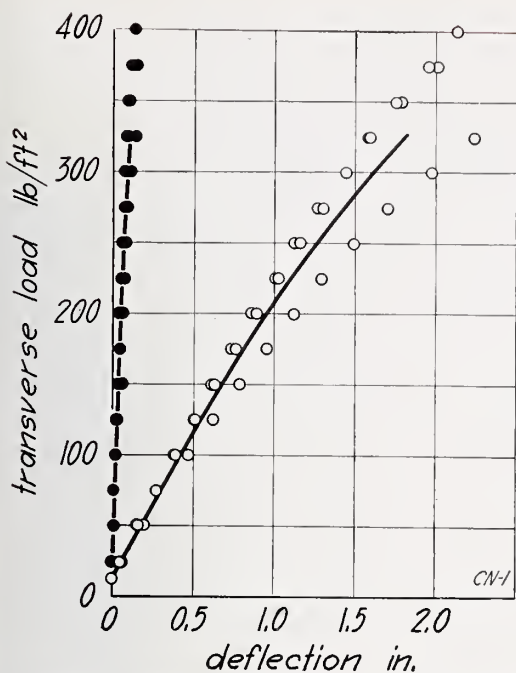
FIGURE 30.—Transverse load on wall CN, load applied to inside face.

Load-deflection (open circles) and load-set (solid circles) results for specimens CN-T1, T2, and T3 on the span 7 ft 6 in.

Under a load of 350 lb/ft² on specimen *T1*, one outer stud partially ruptured. The center stud and one outer stud of specimen *T2* began to rupture at a load of 400 lb/ft², and one outer stud of *T3* began to rupture under a load of 275 lb/ft². Under the maximum loads, the center stud and one outer stud of each specimen ruptured near midspan. The sheathings of specimens *T1* and *T2* was undamaged,

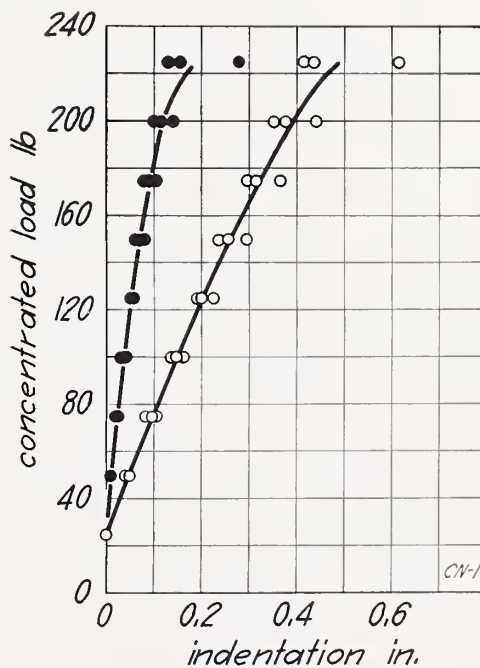
FIGURE 32.—Concentrated load on wall CN, load applied to inside face.

Load-indentation (open circles) and load-set (solid circles) results for specimens CN-P1, P2, and P3.

The concentrated load was applied to the inside face of specimens CN-P1, P2, and P3
